Manhole Inspection Summary

Manhole # S23KK1020MH

Insp Date: **11/20/06 10:45 AM**

Location Address: **4410 GRAND VIEW AVE**

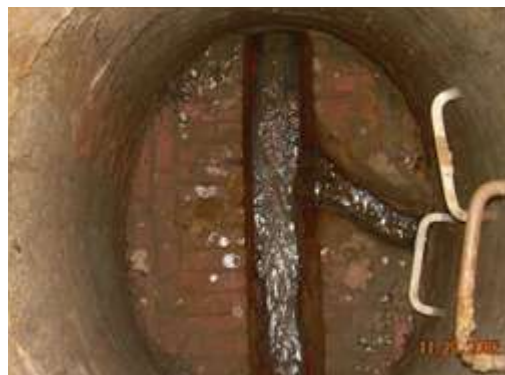
Top View

☒ **Debris** (not Condition related)

Bench debris.

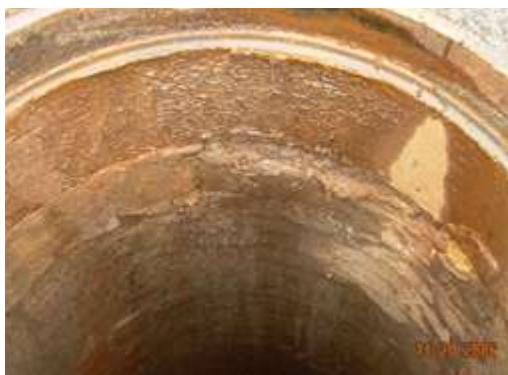
Defect

☒ **Leaks**

Condition: ☐ Sound ☐ Cracked ☐ Root Intrusion ☐ Loose Brick ☒ **Deteriorated**

Infiltration: ☐ None ☒ **Joint** ☐ Cracks ☒ **Mortar** ☐ Roots ☐ Wall

Frame leaks. Adjustment deterioration and infiltration.

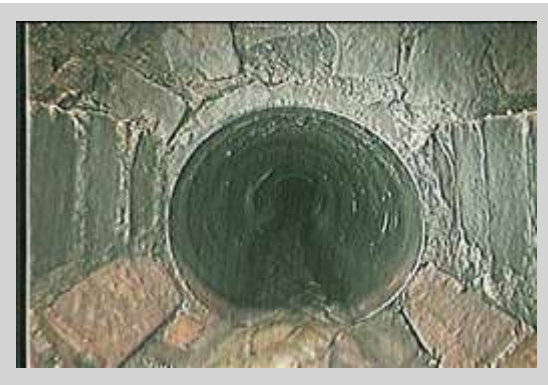
8 in. Circular Gravity Sewer Pipe Out @ 12 O'Clock

Condition: ☐ Sound ☐ Cracked ☐ Root Intrusion ☒ **Deteriorated** ☐ Leaks ☐ Debris

Channel deterioration.
